ABB MEASUREMENT & ANALYTICS | TECHNICAL BULLETIN | 2106369TB-TB214

Software Update

300 MHZ RMC-100

September 19, 2019

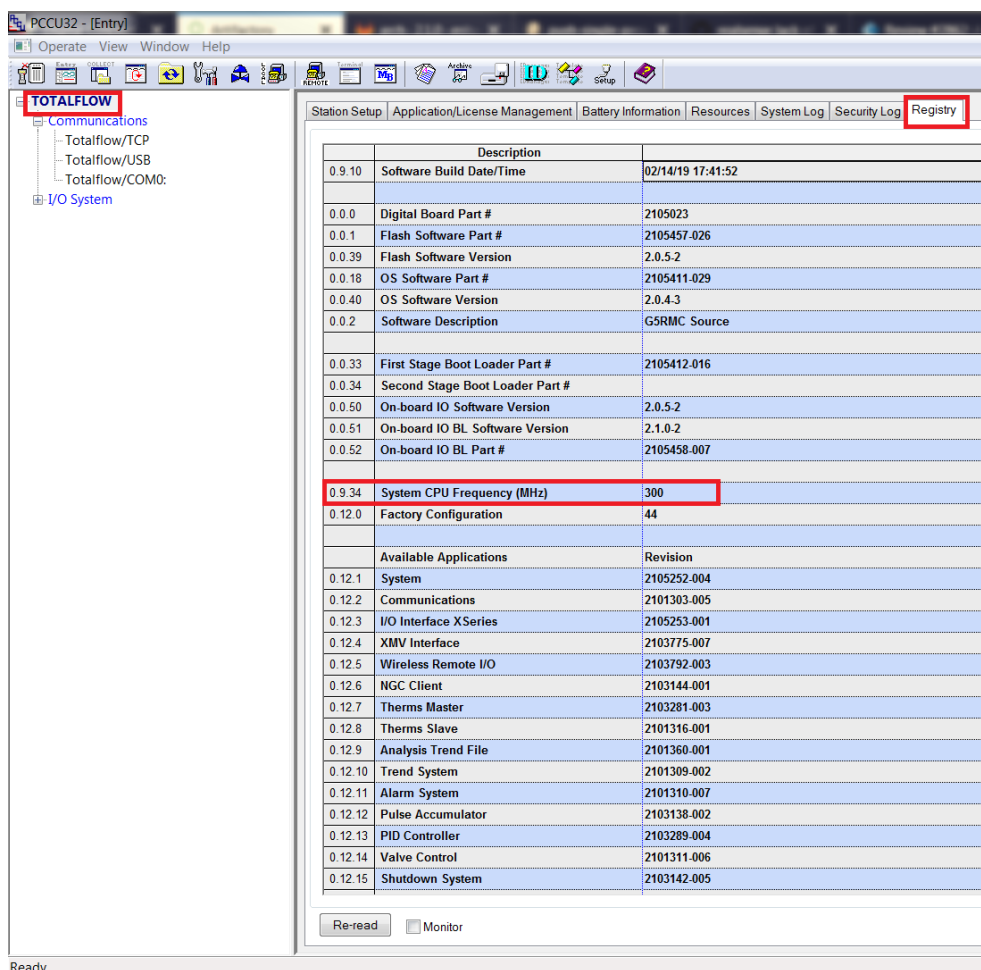
1. Connect with the device using PCCU Entry Mode. The latest version of PCCU is recommended for this procedure.
2. Click the station ID on the navigation tree (Default Station ID is **TOTALFLOW**). See following figure).
3. Click **Registry**.
4. Locate the System CPU Frequency (MHz) parameter. If this value is **300**, the RMC is a 300 MHz device. Proceed to Section 4 and 5 to apply the patch.

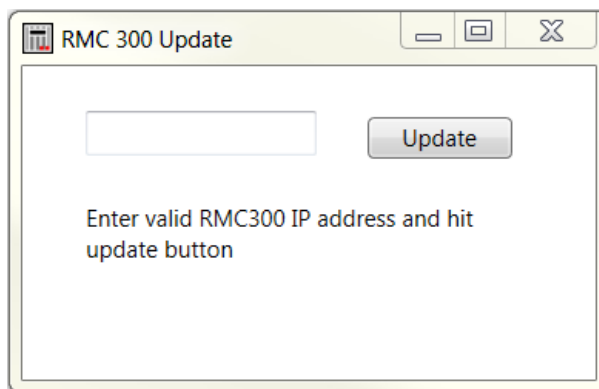
1. Double click **RMC300Update.exe**. The following window displays.

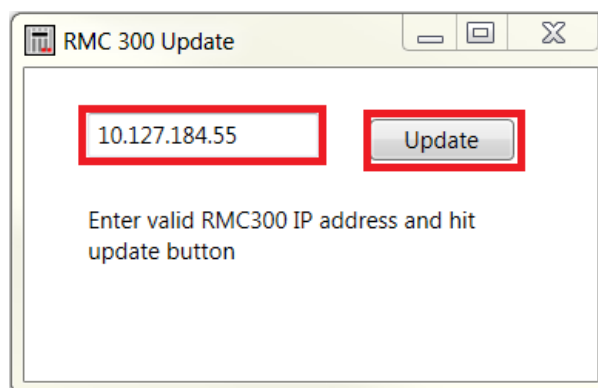
2. Enter the IP address of the RMC 300 MHz device in the window provided, click **Update**.

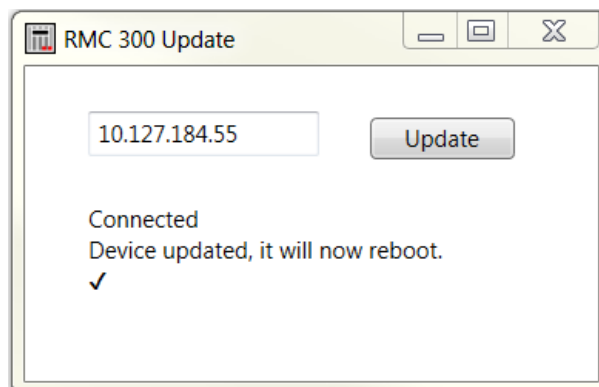
3. If the procedure is successful, the following messages are displayed as shown in the image below.
