ABB industrial drives

Troubleshooting manual

ACS580MV primary control program

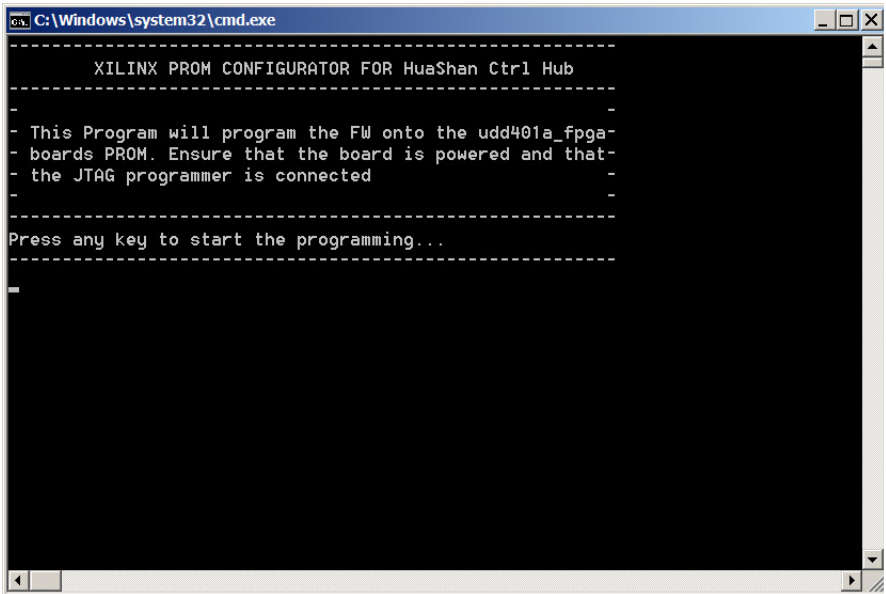
1. Switch off the control power
2. Remove the daughter boards DB2 and DB3 to get access the X5 connector on control hub
3. Connect XILINX platform cable USB II to X5 connector on control hub
4. Switch on the control power
5. Run PROG_MHDCH.bat batch file to program the control hub. Following window will open:

```
C:\Windows\system32\cmd.exe
-----
XILINX PROM CONFIGURATOR FOR HuaShan Ctrl Hub
-----
- This Program will program the Fw onto the udd401a_fpga-
- boards PROM. Ensure that the board is powered and that-
- the JTAG programmer is connected
-----
Press any key to start the programming...
```

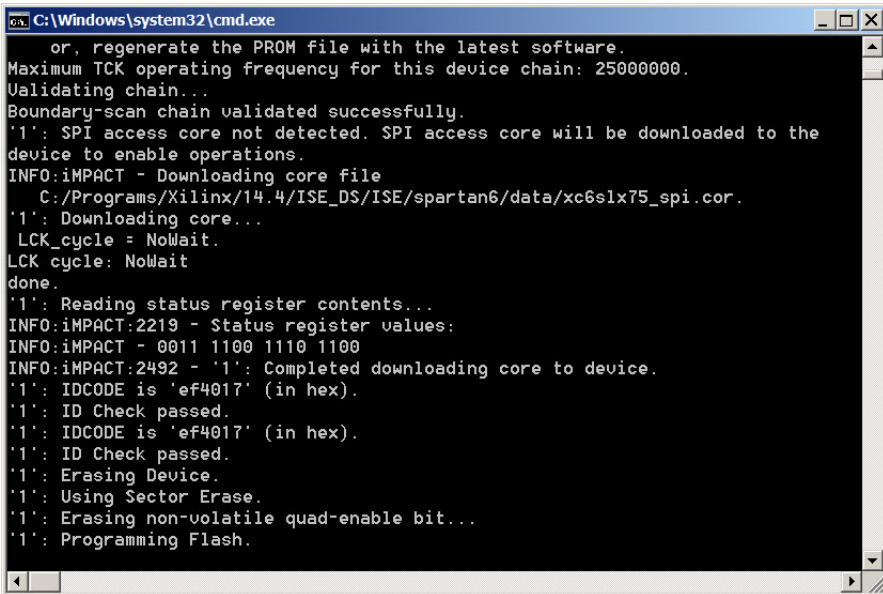
6. After pressing Enter many messages will be shown on screen and finally the

screen will stay longer with the following message:

```
C:\Windows\system32\cmd.exe
or, regenerate the PROM file with the latest software.
Maximum TCK operating frequency for this device chain: 25000000.
Validating chain...
Boundary-scan chain validated successfully.
'1': SPI access core not detected. SPI access core will be downloaded to the
device to enable operations.
INFO:iMPACT - Downloading core file
C:/Programs/Xilinx/14.4/ISE_DS/ISE/spartan6/data/xc6s1x75_spi.cor.
'1': Downloading core...
LCK_cycle = NoWait.
LCK cycle: NoWait
done.
'1': Reading status register contents...
INFO:iMPACT:2219 - Status register values:
INFO:iMPACT - 0011 1100 1110 1100
INFO:iMPACT:2492 - '1': Completed downloading core to device.
'1': IDCODE is 'ef4017' (in hex).
'1': ID Check passed.
'1': IDCODE is 'ef4017' (in hex).
'1': ID Check passed.
'1': Erasing Device.
'1': Using Sector Erase.
'1': Erasing non-volatile quad-enable bit...
'1': Programming Flash.
```

Programming of the control hub takes 3-4 minutes.

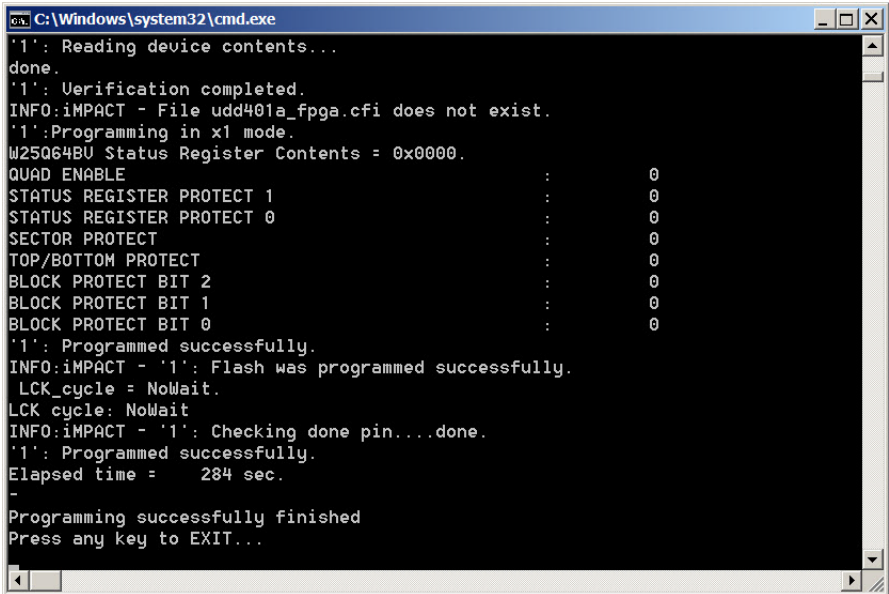
7. When the programming is over following screen will show:

C:\Windows\system32\cmd.exe
'1': Reading device contents...
done.
'1': Verification completed.
INFO:iMPACT - File udd401a_fpga.cfi does not exist.
'1': Programming in x1 mode.
W25Q64BU Status Register Contents = 0x0000.
QUAD ENABLE                : 0
STATUS REGISTER PROTECT 1  : 0
STATUS REGISTER PROTECT 0  : 0
SECTOR PROTECT             : 0
TOP/BOTTOM PROTECT         : 0
BLOCK PROTECT BIT 2        : 0
BLOCK PROTECT BIT 1        : 0
BLOCK PROTECT BIT 0        : 0
'1': Programmed successfully.
INFO:iMPACT - '1': Flash was programmed successfully.
  LCK_cycle = NoWait.
LCK cycle: NoWait
INFO:iMPACT - '1': Checking done pin....done.
'1': Programmed successfully.
Elapsed time = 284 sec.
-
Programming successfully finished
Press any key to EXIT...

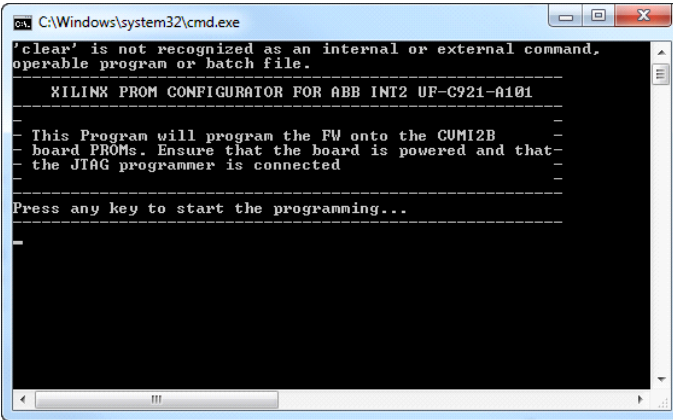
1. Switch off the control power.
2. Connect XILINX platform cable USB II to X1301 connector on CVM12.
3. Switch on the control power.
4. Run PROG_LXES.bat batch file to program the CVM12. Following window will open:

-----
XILINX PROM CONFIGURATOR FOR ABB INT2 UF-C921-A101
-----
- This Program will program the FW onto the CVM12B
- board PROMs. Ensure that the board is powered and that
- the JTAG programmer is connected
-----

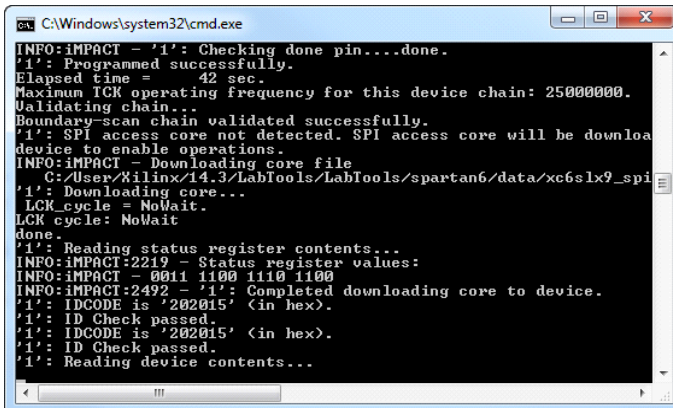
5. After pressing Enter many messages will be shown on screen and finally the screen will stay longer with the following message:

```
C:\Windows\system32\cmd.exe
INFO:IMPACT - '1': Checking done pin...done.
'1': Programmed successfully.
Elapsed time = 42 sec.
Maximum TCK operating frequency for this device chain: 25000000.
Validating chain...
Boundary-scan chain validated successfully.
'1': SPI access core not detected. SPI access core will be download
device to enable operations.
INFO:IMPACT - Downloading core file
C:\User\Xilinx\14.3\LabTools\LabTools\spartan6\data\xc6slx9_spi
'1': Downloading core...
LCK cycle = NoWait.
LCK cycle: NoWait
done.
'1': Reading status register contents...
INFO:IMPACT:2219 - Status register values:
INFO:IMPACT: 0011 1100 1110 1100
INFO:IMPACT:2492 - '1': Completed downloading core to device.
'1': IDCODE is '202015' (in hex).
'1': ID Check passed.
'1': IDCODE is '202015' (in hex).
'1': ID Check passed.
'1': Reading device contents...
```

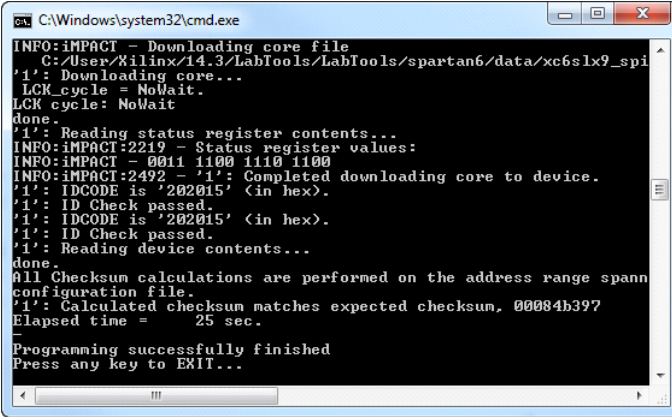
6. When the programming is over following screen will show:

C:\Windows\system32\cmd.exe
INFO:IMPACT - Downloading core file
C:\User\Xilinx\14.3\LabTools\LabTools\spartan6\data\xc6s1x9_spi
'1': Downloading core...
LCK_cycle = NoWait.
LCK_cycle: NoWait
done.
'1': Reading status register contents...
INFO:IMPACT:2219 - Status register values:
INFO:IMPACT - 0011 1100 1110 1100
INFO:IMPACT:2492 - '1': Completed downloading core to device.
'1': IDCODE is '202015' (in hex).
'1': ID Check passed.
'1': IDCODE is '202015' (in hex).
'1': ID Check passed.
'1': Reading device contents...
done.
All Checksum calculations are performed on the address range spann
configuration file.
'1': Calculated checksum matches expected checksum, 00084b397
Elapsed time = 25 sec.
-
Programming successfully finished
Press any key to EXIT...

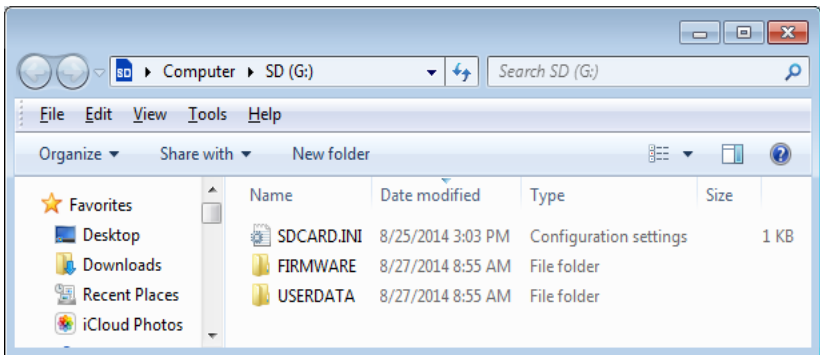
1. Save the following files and folders to the SD card (MC502) root folder. Files can be found in the MHDRE release package (folder \04_IOController SW):

Note: Only MC502 SD card can be used. This is not the same SD card which is plugged into the BCU.

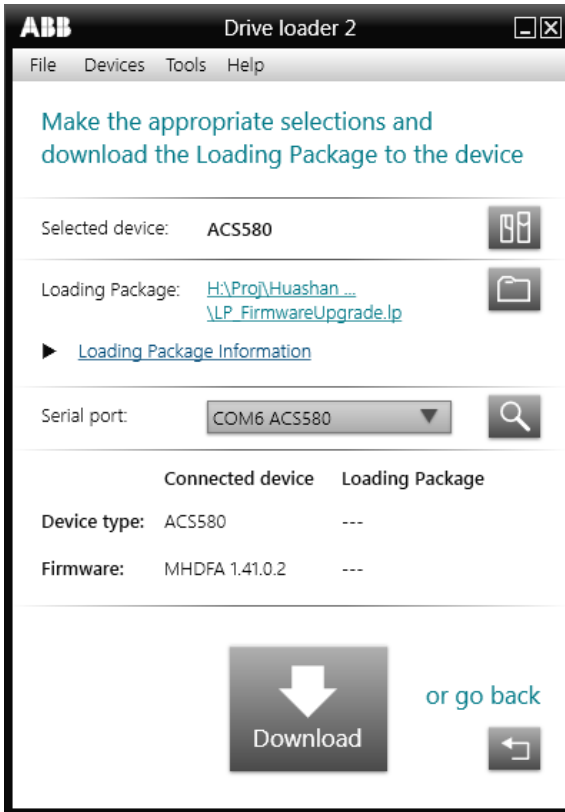
2. Start Drive loader 2 and select the file LP_FirmwareUpgrade.lp from the MHDRE release package (folder \01_BCON SW). Select ACS580 for the drive type and wait until the tool identifies the connection to the drive. Click “Download” button when ready:

Note: Drive composer and DriveStartup PC tools must be closed to enable connection to the drive.

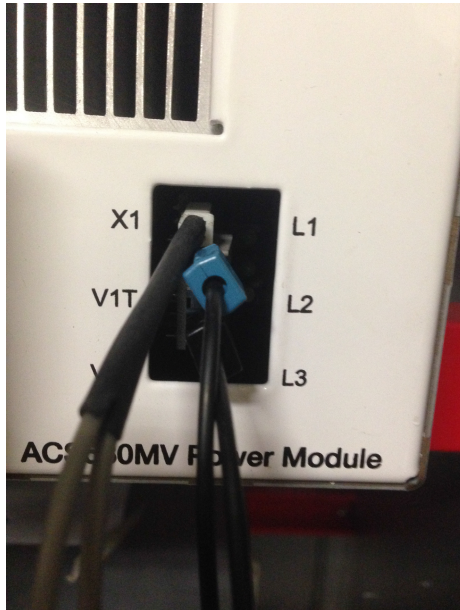
1. Disconnect the original POF links from the first power module. Disconnect the original +5.5V power supply cable from the first power module. Connect the USB to FO serial cable to power module's POF links. Make sure that the correct POF link is connected to TX and RX channel by obeying the color of the POF link cable and POF link connectors on power module.
-

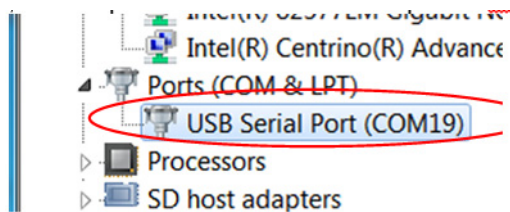
2. Check the port of the USB to FO serial cable on your PC (Control panel -> System -> Device Manager):

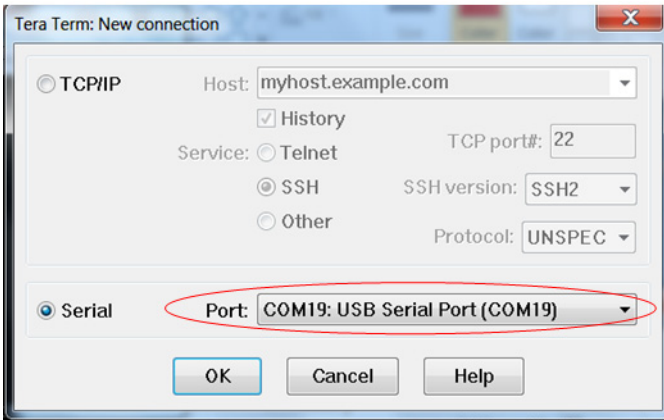
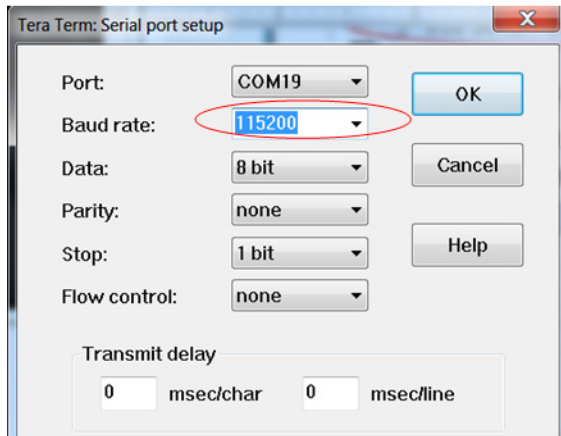
3. Open the "Tera Term" PC tool and set the serial port to the one where Serial to POF link cable is connected (COM19 in the example here). Set the baud rate to 115200.
-

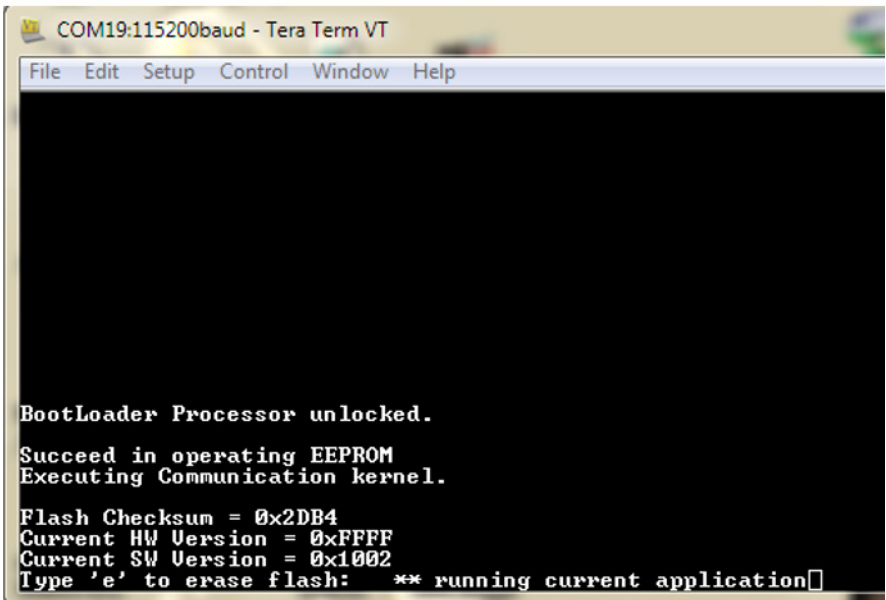
4. Connect the auxiliary +5.5V power supply cable (part of the USB-POF link cable) to +5.5V power supply connector on the power module. After that the DSP of the power module will boot up. After the DSP boots up the Tera Term receives information from DSP:

The image shows a screenshot of a Tera Term VT terminal window. The title bar reads "COM19:115200baud - Tera Term VT". The menu bar includes "File", "Edit", "Setup", "Control", "Window", and "Help". The terminal output is as follows:

```
BootLoader Processor unlocked.  
Succeed in operating EEPROM  
Executing Communication kernel.  
Flash Checksum = 0x2DB4  
Current HW Version = 0xFFFF  
Current SW Version = 0x1002  
Type 'e' to erase flash:  ** running current application
```

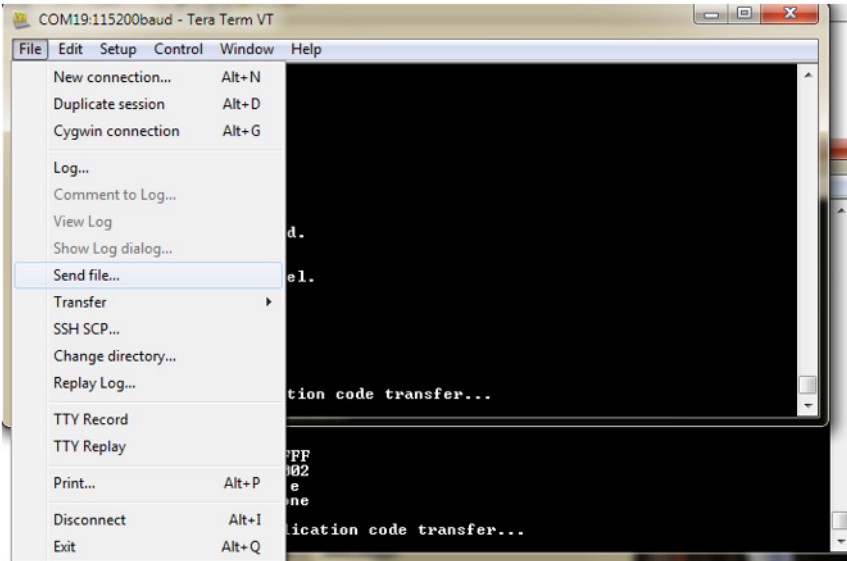
5. After Tera Term displays the text "Type 'e' to erase flash:" just press letter "e" on the keyboard.
6. Open the File menu and chose "Send file":

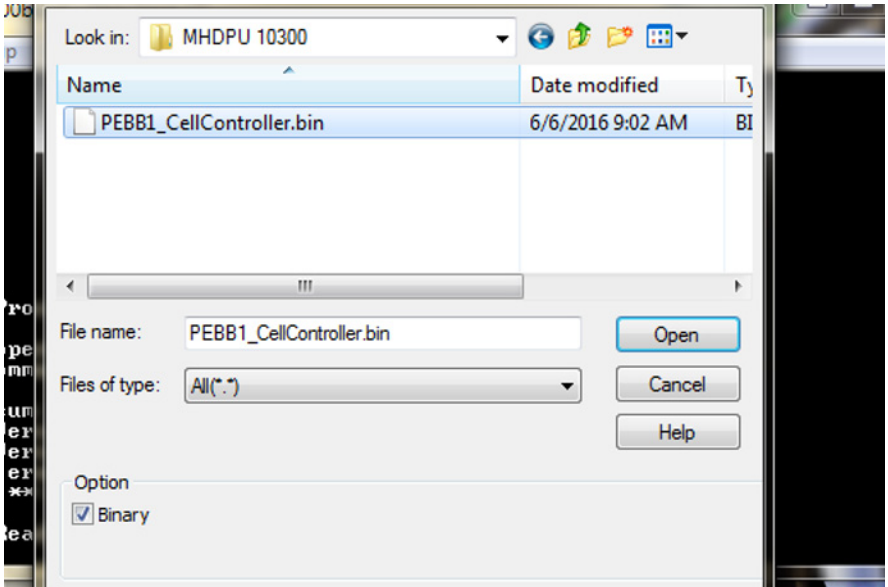
Select the PEBB1_CellController.bin file from the MHDRE loading package (folder \02_PowerModule SW).

Important: Make sure to select the option “Binary”! If not selected, the software download will fail.

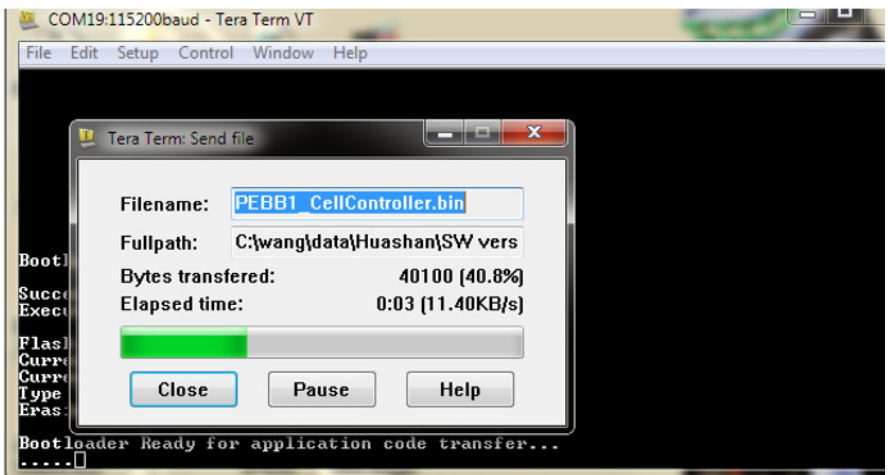
7. Press “Open” to start the download:

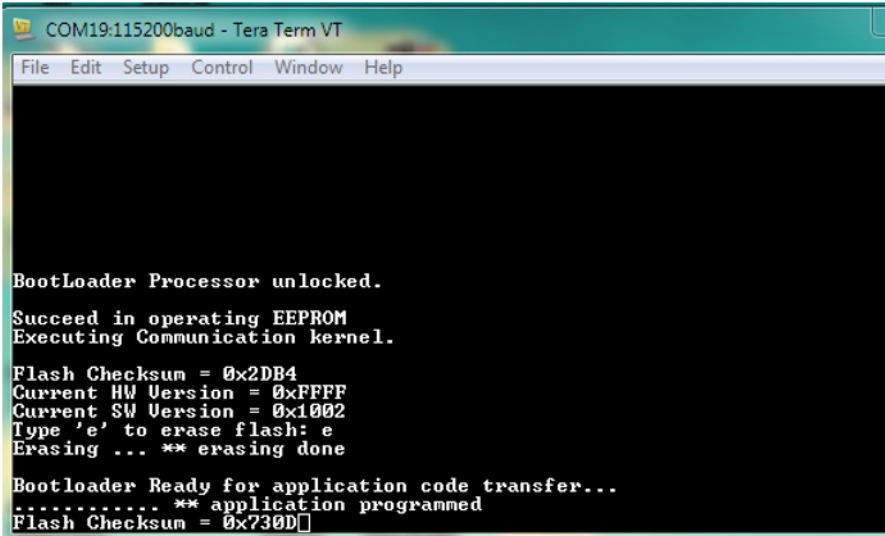
8. Once the download is successfully finished the following message will be shown:

The image shows a screenshot of a Tera Term VT terminal window. The title bar reads "COM19:115200baud - Tera Term VT". The menu bar includes "File", "Edit", "Setup", "Control", "Window", and "Help". The terminal output is as follows:

```
BootLoader Processor unlocked.
Succeed in operating EEPROM
Executing Communication kernel.

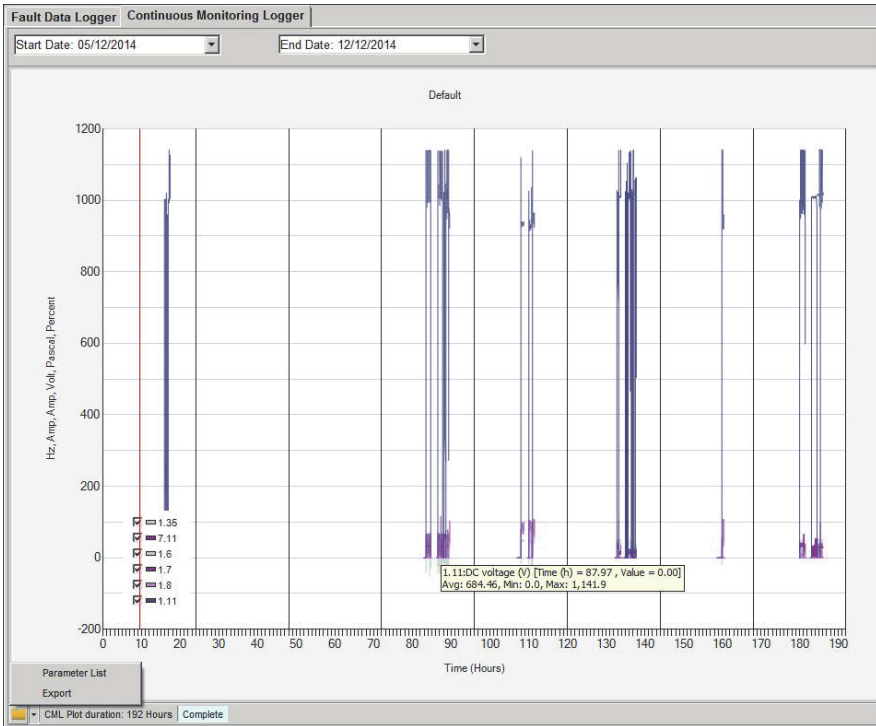
Continuous monitoring logger collects the predefined drive data with slow sample time (10s to 500s, depending on particular drive parameter). Data collected in the Continuous monitoring logger are intended for analysis of the drive operation over longer periods of time. The user can select start and end date to view the time plot. All monitored drive parameters are grouped in several groups (called CML plots) that can be selected by right clicking on the graph area. To display or hide some of the parameters in the graph, check boxes next to parameter numbers can be used. Hovering with the mouse pointer over the parameter signal in the graph displays parameter name, sample time, sample value, average, minimum and maximum value.

Figure: Continuous monitoring logger

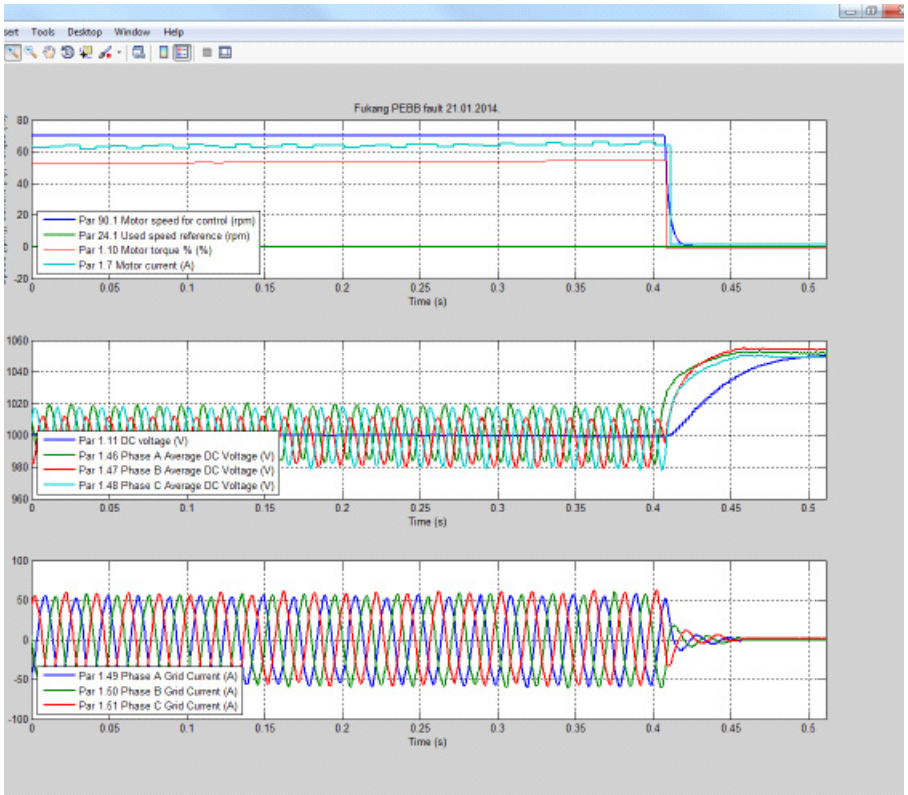
The data from the fault data logger are exported in .dexp format. If Matlab is available, the data can be imported using ABB in-house script in the following way: `log_data = read_dexp('FileName.dexp')`. The script will plot the data in predefined format, like in the following figure. If Matlab is not available, the .dexp file can be imported and analyzed in Excel.

Figure: Example of fault data logger data plotted using Matlab script

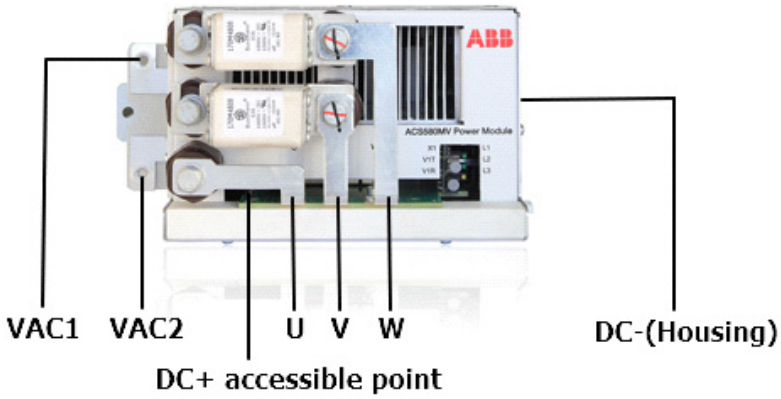
Figure 1: R1-R3 power module – Measuring points

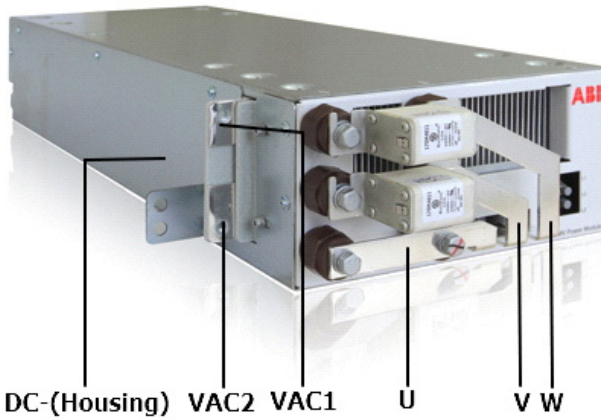
Figure 2: R4-R6 power modules – Measuring points 1

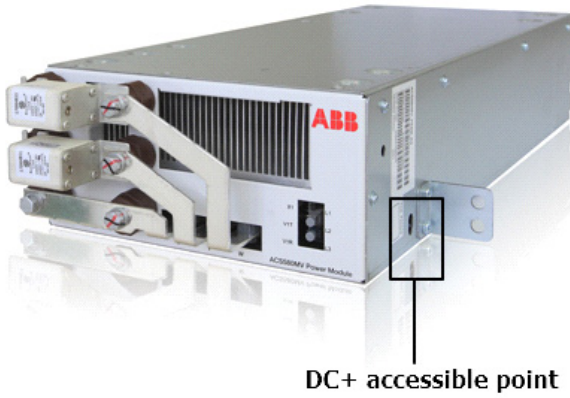
Figure 3: R4-R6 power modules – Measuring points 2

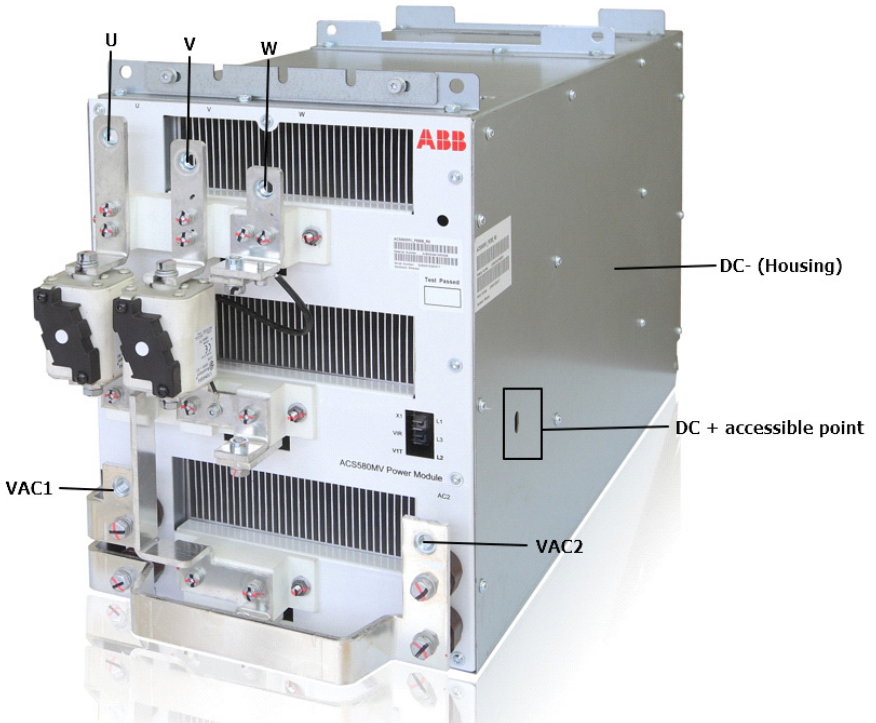
Figure 4: R7-R9 power modules – Measuring points

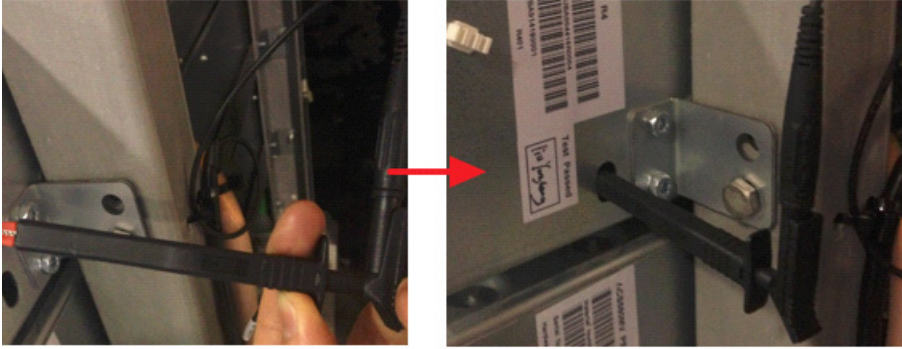
Figure 5: How to use the clip to access DC+ point (R1-R9)

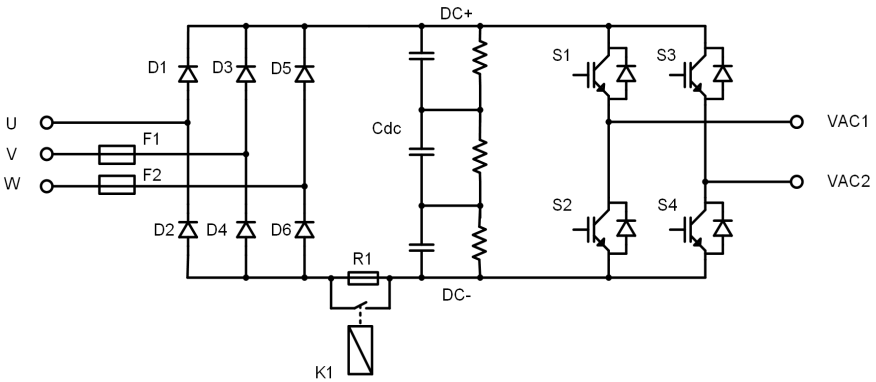
Figure 6: R1-R6 power modules main circuit diagram

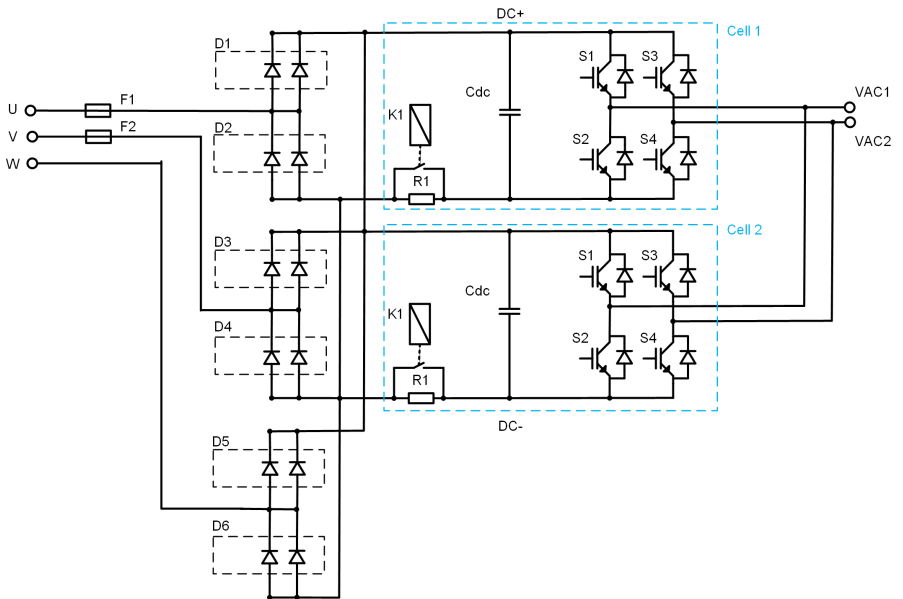
Figure 7: R7 power module main circuit diagram

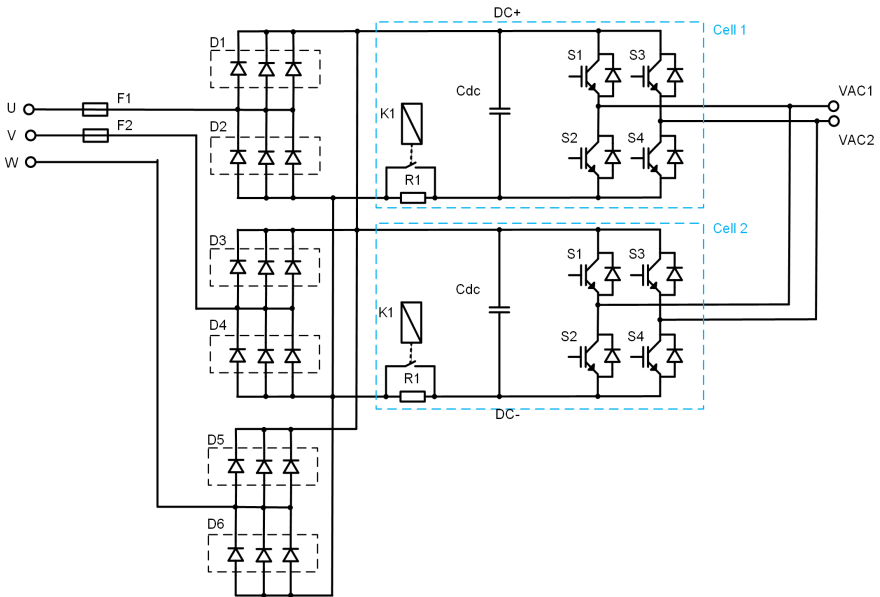
Figure 8: R8 power module main circuit diagram

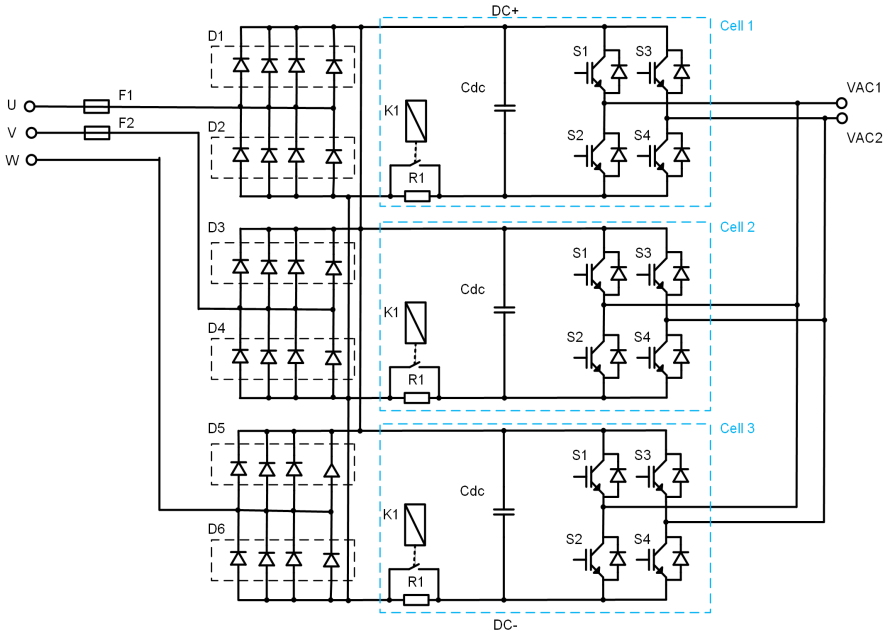
Figure 9: R9 power module main circuit diagram

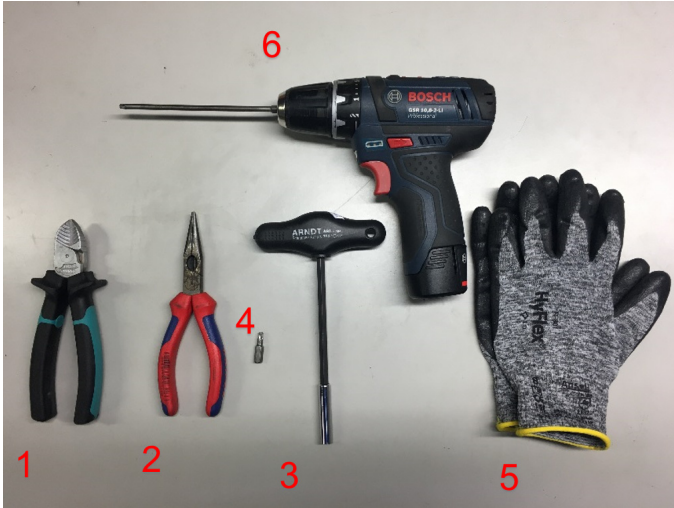
Necessary tools:

Index	Tool Type
1	Cable cutter
2	Sharp-nose plier
3	Combination screwdriver
4	T25 torx bit
5	Protective gloves
6	Auto screwdriver

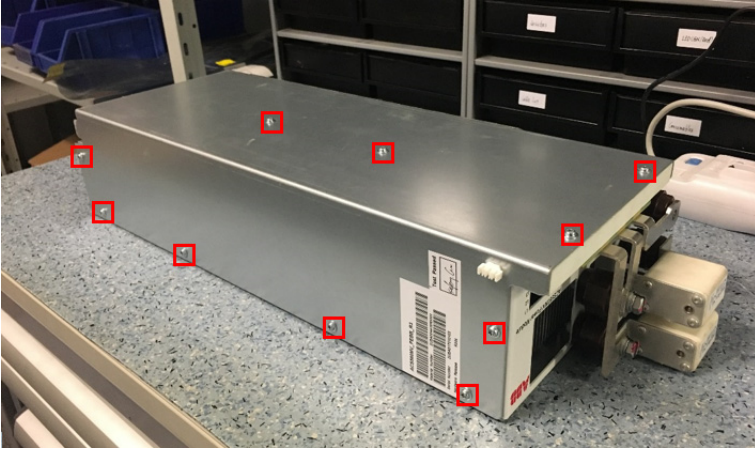
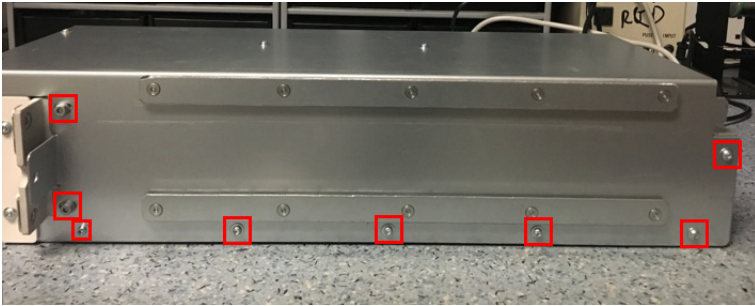
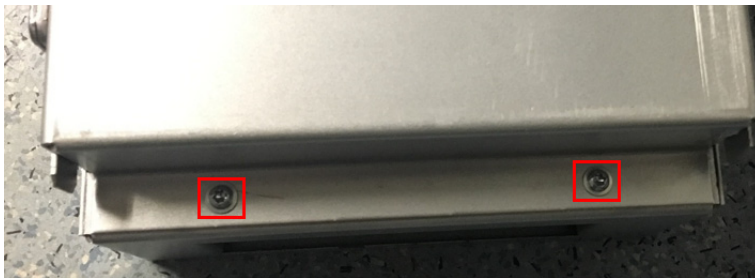
Step 1: remove red marked screws and open the PEBB.

Side plate of the PEBB;
Remove red marked screws;
Open orange marked cable strap

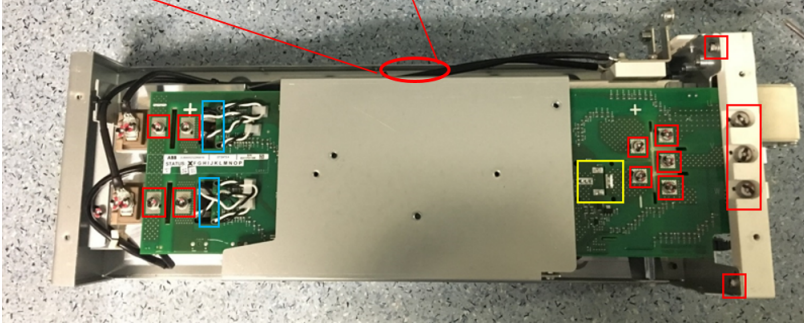
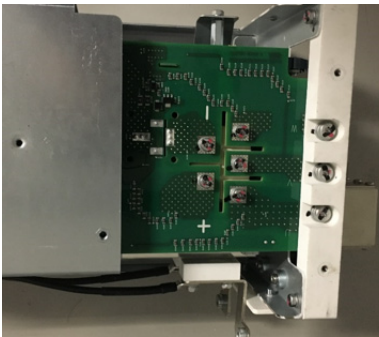
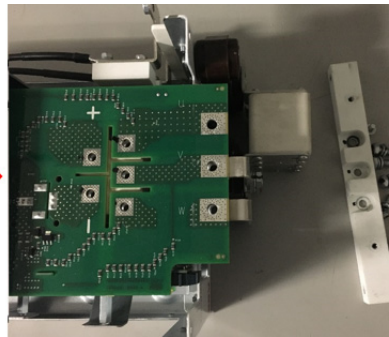
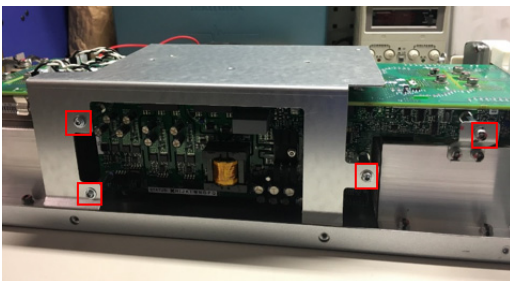
Unscrew all red marked screws.

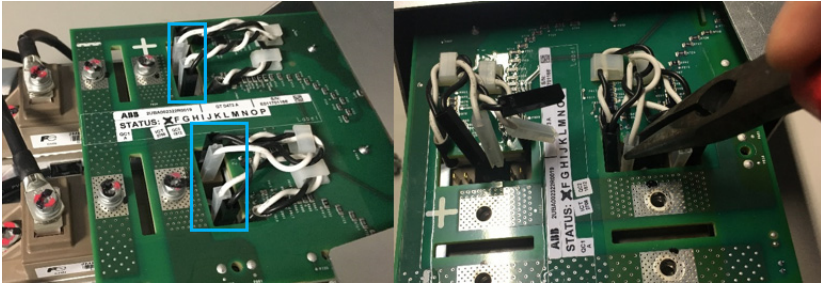
Step 2. Unplug the gate emitter connection.

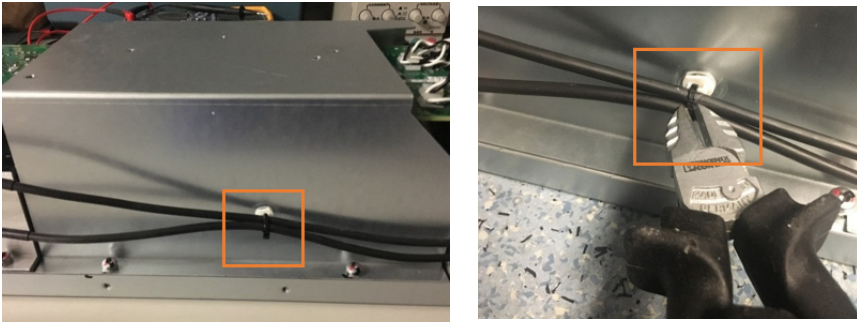
Step 3. Release output voltage cable from cable clamp.

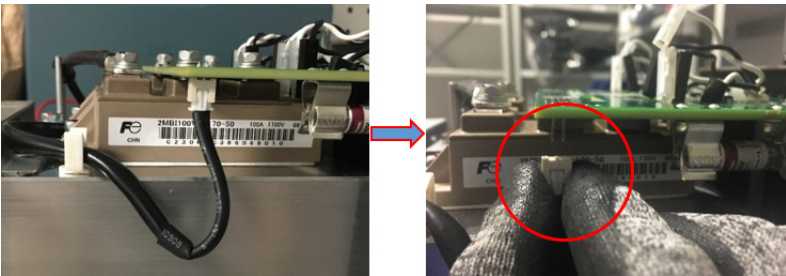
Step 4. Remove cable.

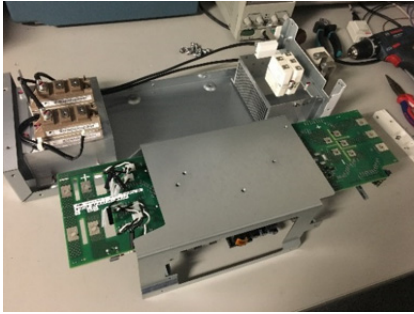
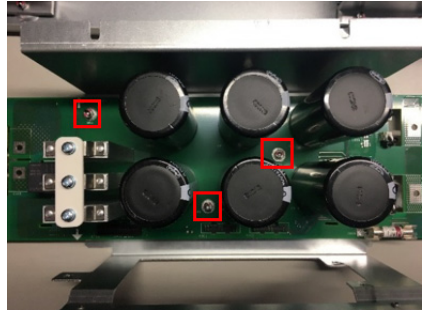
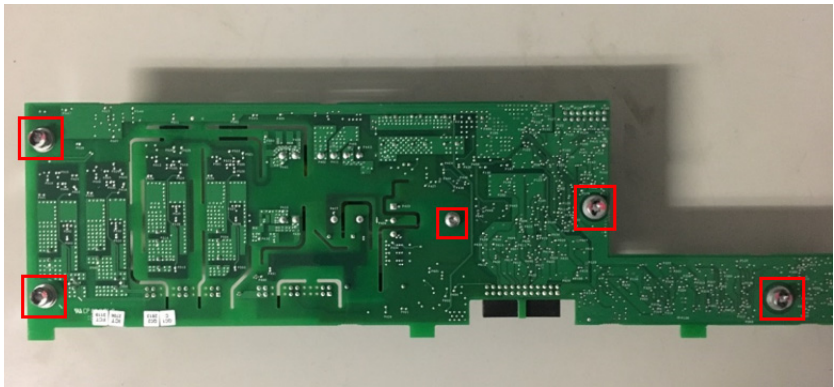
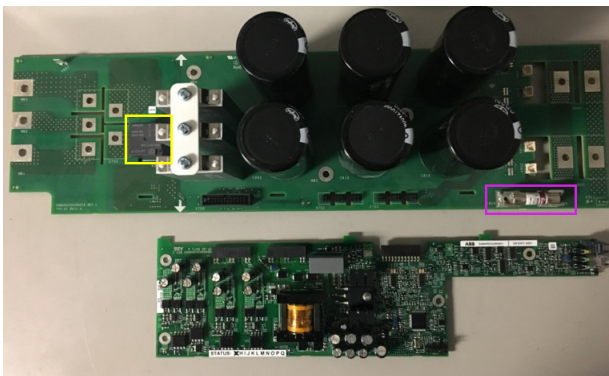
Step 5. Separate HCB board and CB board from holder.

Remove screws marked in red

Yellow:charging relay
Pink internal fuse: shall be always checked with multimeter for resistance; If fuse is open, needs to be reported to support line.

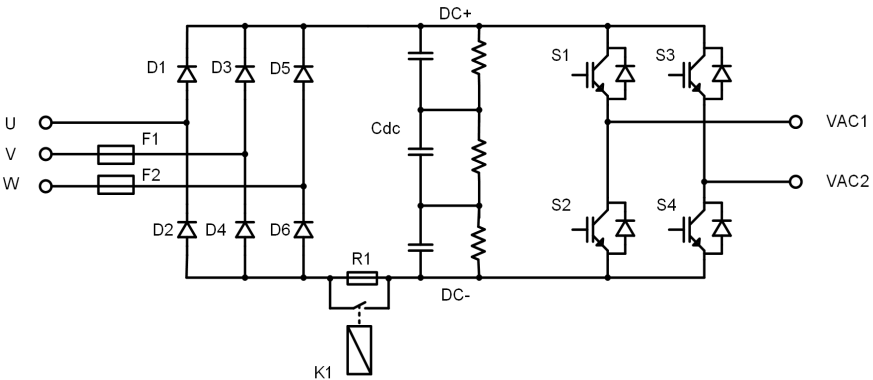
Figure 10: Main Circuit of Power Module

At the very beginning of charging, full voltage (about more than 1000V DC) applied on charging resistor R1 (also between one main contact and coil of K1), somehow the insulation breaks down inside K1 (the arc we found inside charging relay). High voltage goes to relay control circuit and causes some visible damage on Heavy Copper Board (HCB) or on Control Board (CB).

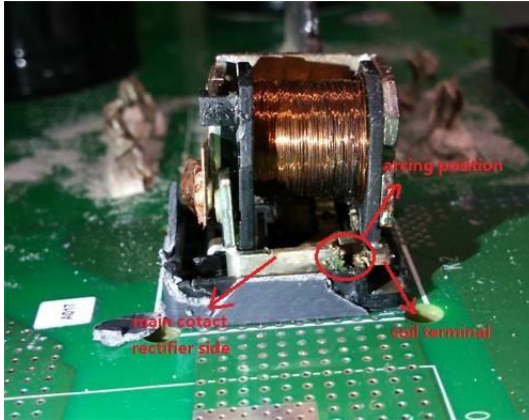
Figure 11: Arc inside relay

The reason why there is an arc inside relay is that liquid goes onto the sealed relay during manufacturing. New produced boards are free of the problem.

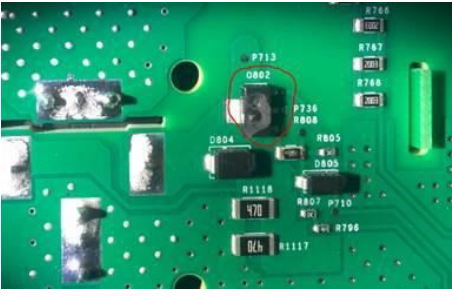
Figure 12: Q802 position

1. Q802 on HCB board is exploded, which is close to relay area and could be observed after removing the cover of power module. (usually on R1 – R3, fuse on front face may open)

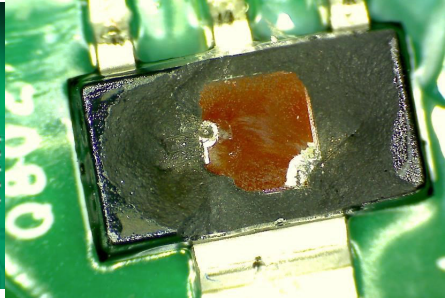
Figure 13: Q802 exploded

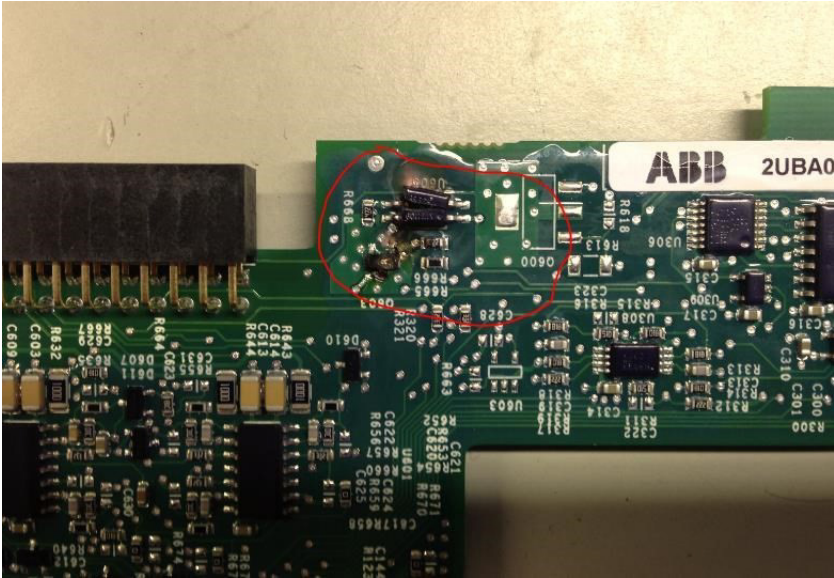
Figure 14: U605 burned on control board

2. U605 or Q603 on control board burned, which is close to material label areas and could be observed after removing the cover of power module. (usually on R4 – R6)

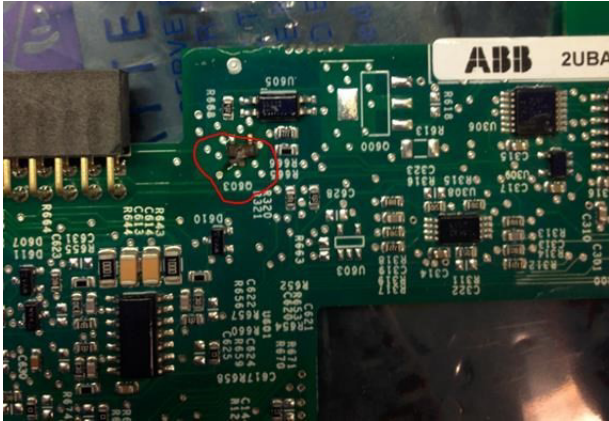
Figure 15: Q603 burned on control board

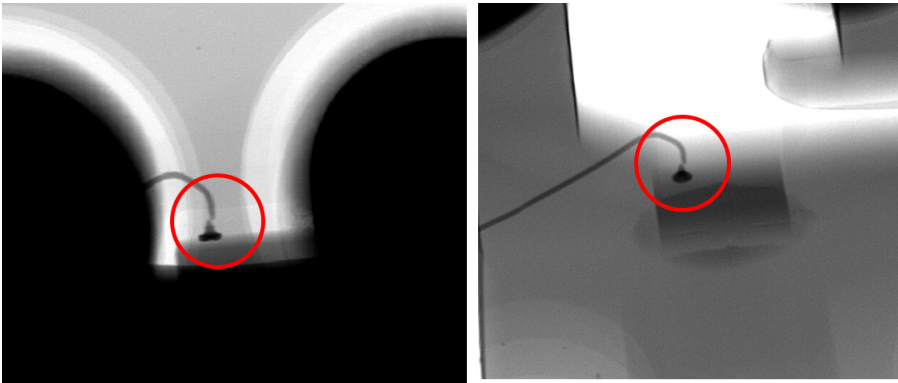
Figure 16: Delamination of fiber optic under X-ray

Delamination is a failure mechanism which affects the interfacial bond between two different material systems. Delamination occurs when an external force was put on two different materials with diverse coefficient of thermal expansion. For plastic packages, delamination usually happen when fiber optic is exposed to high humidity environment. When fiber optic's moisture sensitive part is soldering, high temperature vaporizes moisture rapidly which causes enormous pressure between the interface of two materials, and lead to delamination of fiber optic.

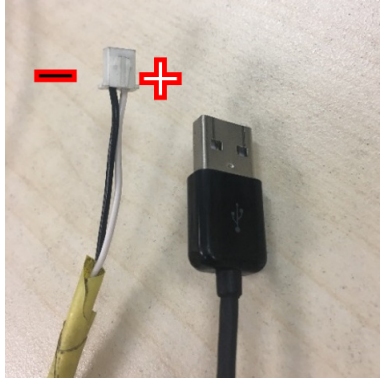
Figure 17: USB-5V power cable

Quick verification with a cable, SAP number tbd can be done on field if FOR still ok or not.

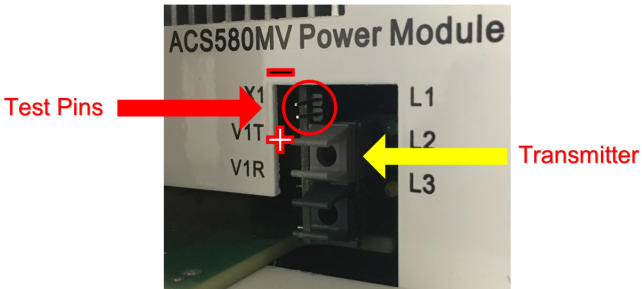
Figure 18 shows, the interface of test pins which can be accessed from outside the PEBB to connect the USB cable for verification.

If there is no red light after connecting the pins correctly to the USB cable, the fiber optic sender is damaged.

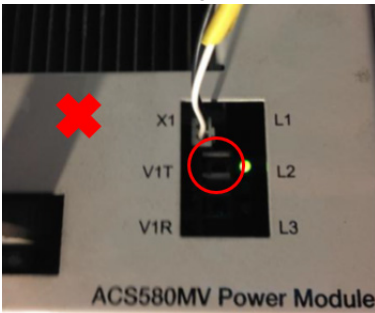
Figure 19: Fiber optic is damaged

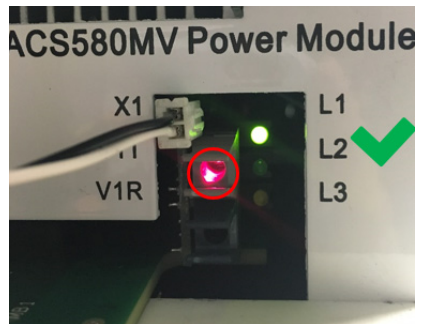
Figure 20: Fiber optic is ok

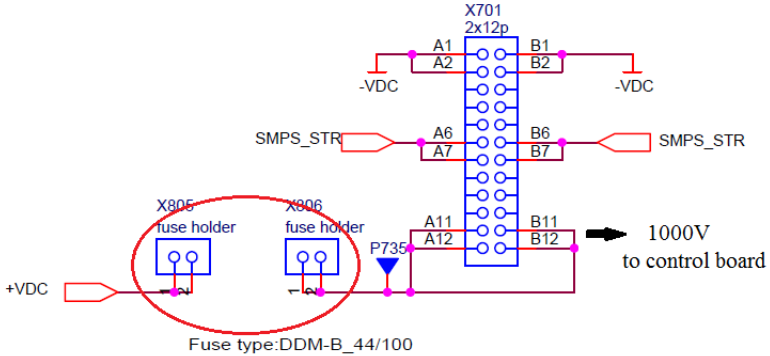
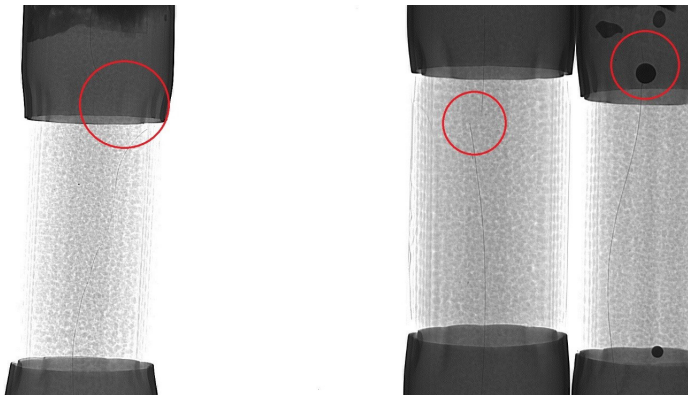
Fuse on HCB of power module open and cause control board cannot work.

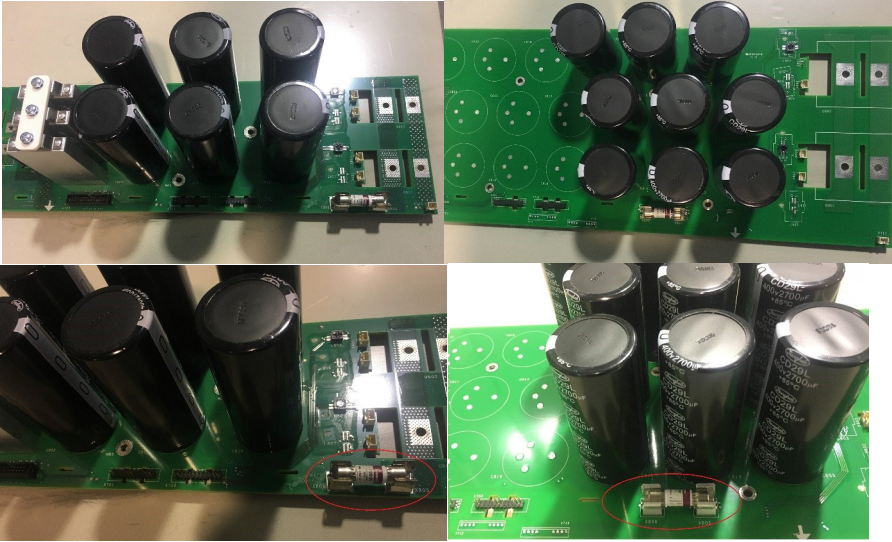
Please refer section [Open the Power Module](#) to open the PEBB first. And you can find fuse link following photos.

Left photos are PEBB0 frame, right photos are PEBB1 frames.

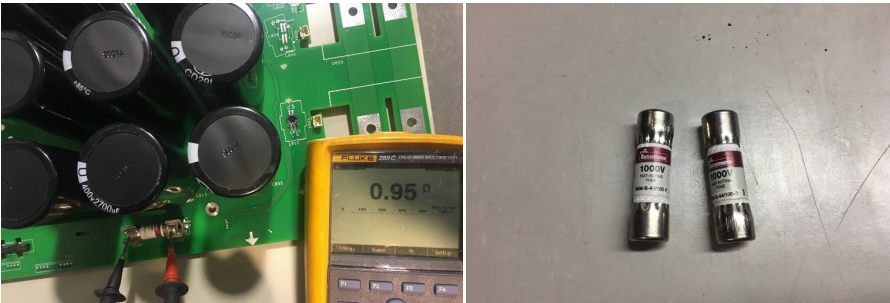
Use multimeter plus and minus probes test two holders of fuse, the value should lower than 1 ohm.
